Technical Data Sheet

Bridge Identification:	1810750000000R01
Facility Carried:	US 23
Feature Intersected:	Huron River
Location:	Ann Arbor
County:	Washtenaw
Region:	University
Year Built:	1956
Year Reconstructed:	1987
Bridge Type:	Two-Girder System
No. of Spans:	11
Deck Area:	41,700 S.F.
Paint System:	Type 4
Paint Area:	191,500 S.F.

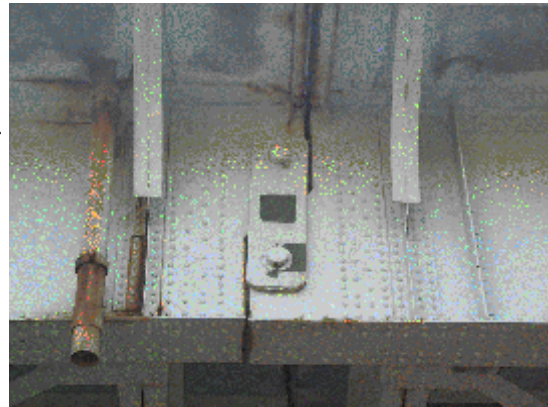
Typical Pin and Hanger Assembly (3)

- ! Pin and hanger assemblies.** (Photo 3)
- ! Tension areas of main girders.** See Figure 1 in the Inspection and Maintenance Program section of this manual for tension areas of main girders.
- ! Floorbeam-to-girder connections.**
- ! Lateral bracing-to-girder connections.**
- ! Tack welds on gusset plates in various locations.**

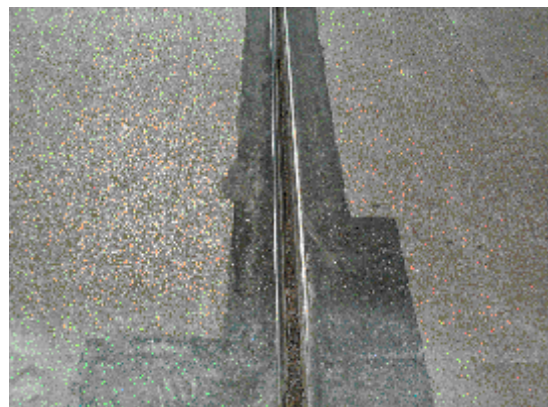
Expansion Joint (4)

- ! Expansion joints.** Monitor condition of these joints for leakage.
